# Mandalay Earthquake Review

- Damage Assessment
- Structural Review
- Damage and Fault Zone Mapping

Myanmar Earthquake Clinics

# M 7.7 - 2025 Mandalay, Burma (Myanmar) Earthquake

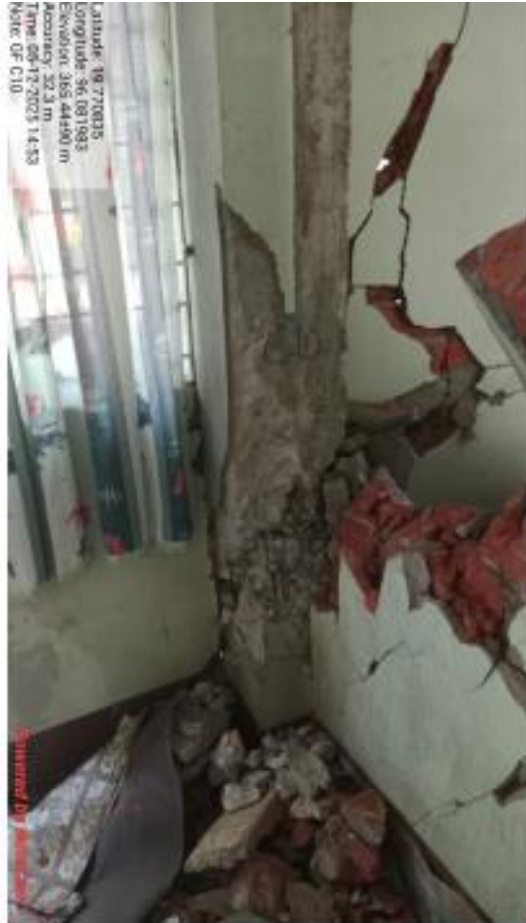
GF - C10 (Severe)

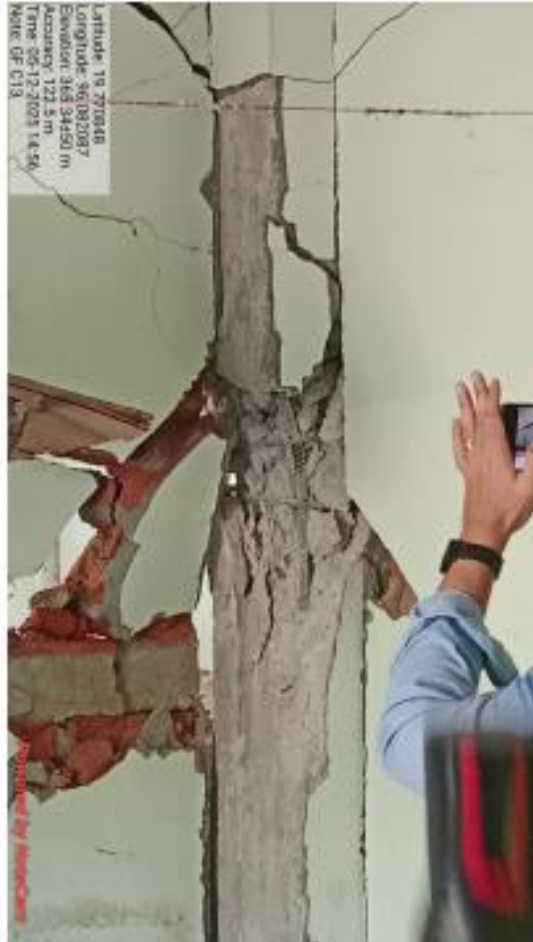
GF - C13 (Severe)

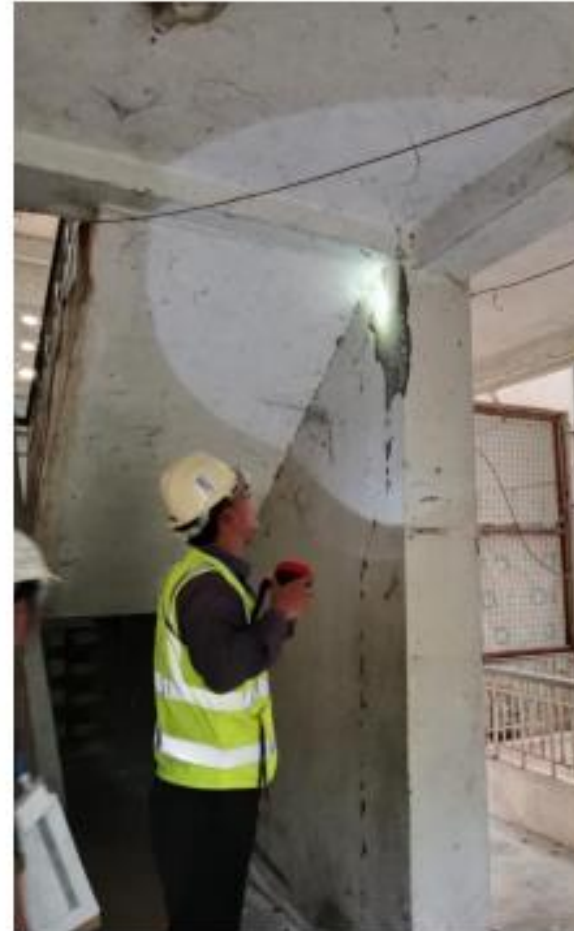
GF - C2 (Moderate)

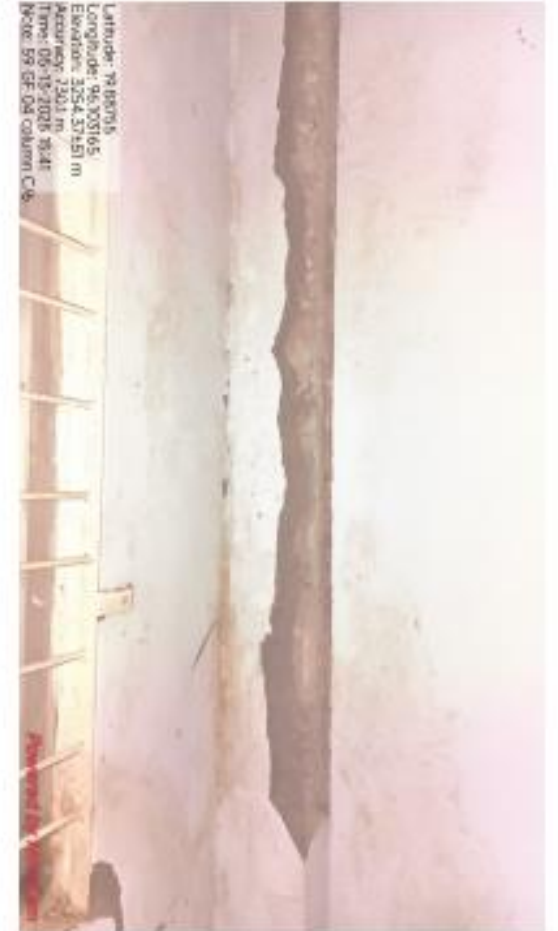
GF - C3 (Moderate)

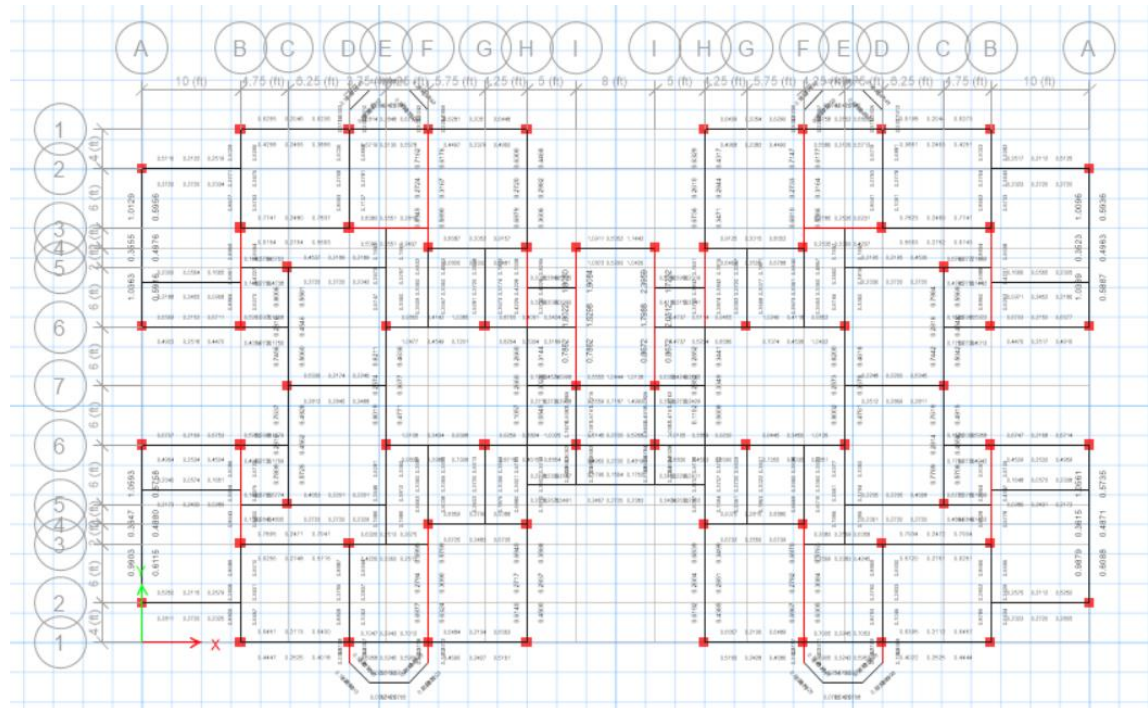
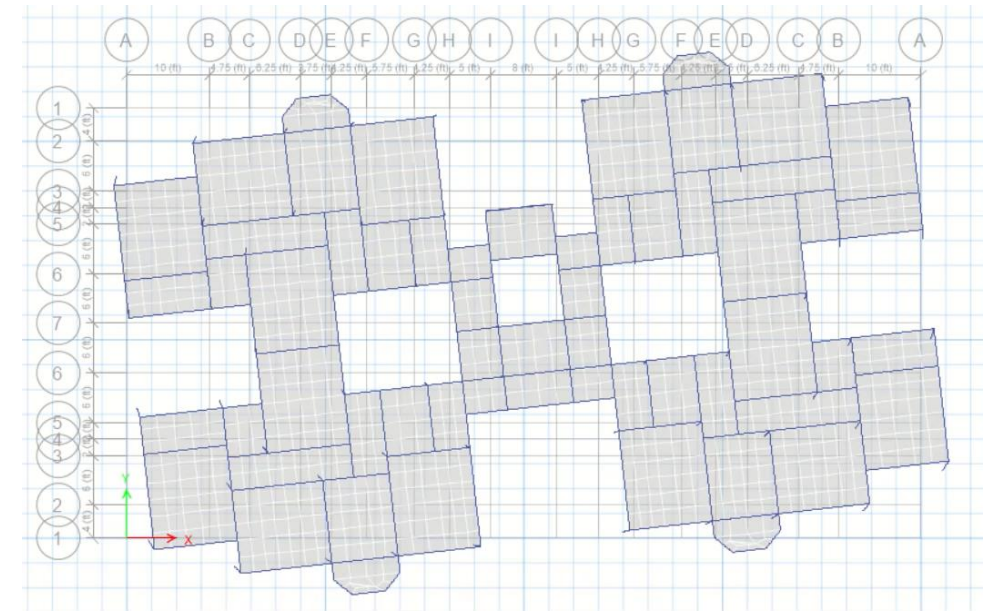
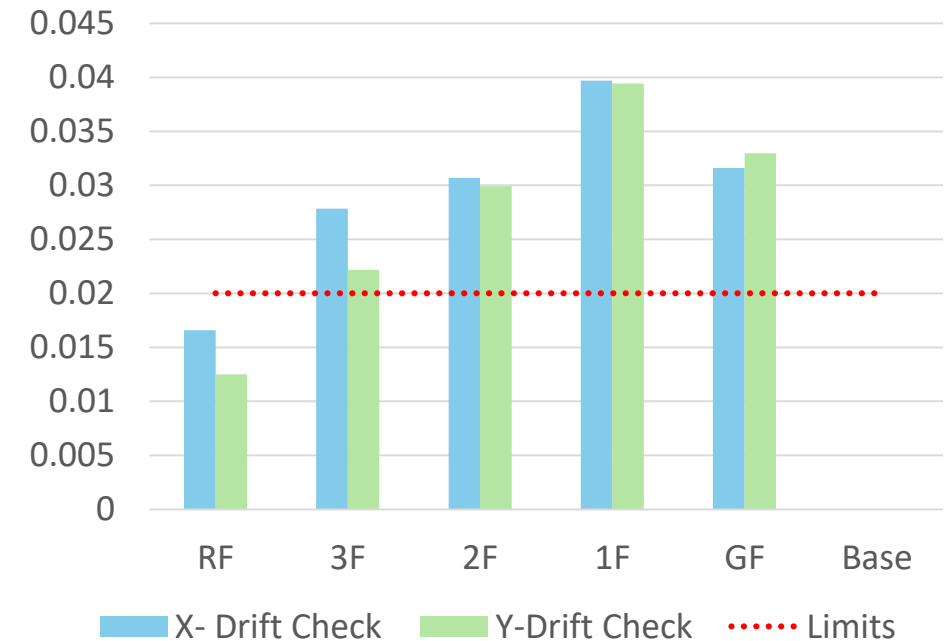
Existing Model Story Drift

- First mode in rotation
- Drift limit exceed
- Many concrete columns are failed in design check.

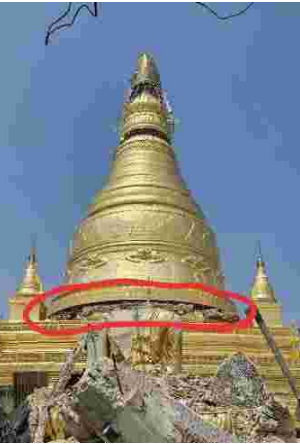
Sunn Oo Ponnya Shin

- Badly damaged
- Now under heavy retrofitting work

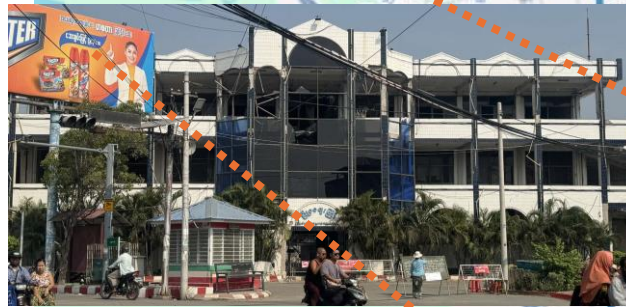
Sagaing Myoma Market

- Main building badly damaged
- Now under heavy retrofitting work

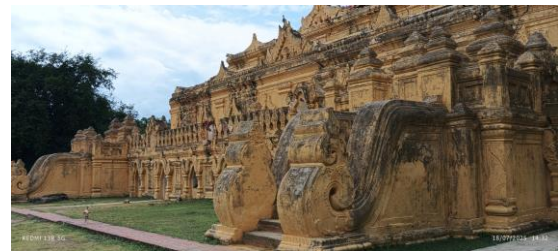
Mae Nu Oakkyang

- Badly damaged
- Debris clearing work completed

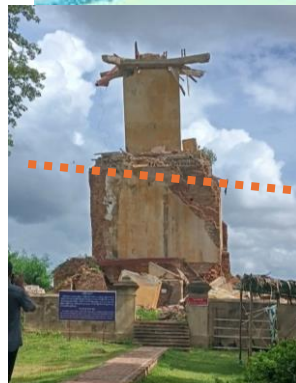
Watch Tower

- Badly damaged
- Debris clearing work

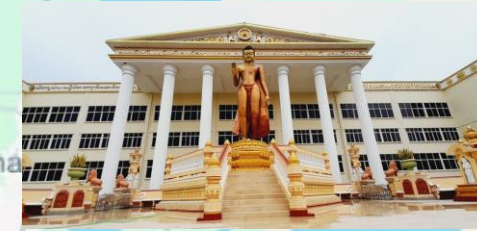
Sitagu Sangga Hall

- Most of ground floor columns damaged
- Waiting for retrofitting design

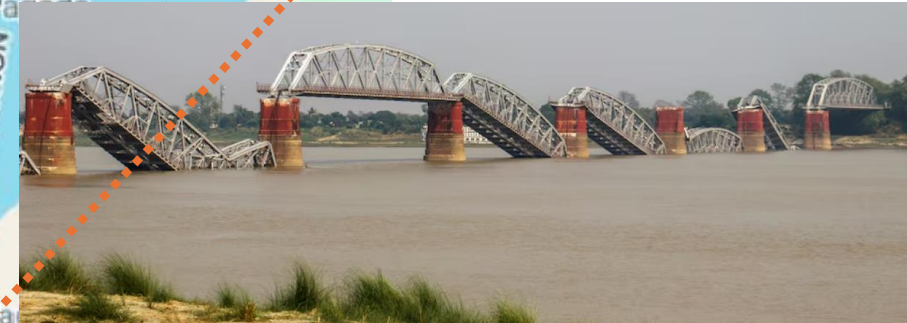
Mandalay Railway Bridge Collapse

- Several segment collapsed
- Clearing work completed

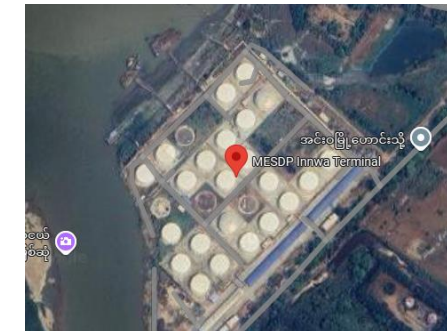
MESDP Innwa Terminal

- No damage report
- Hazardous material storage facility

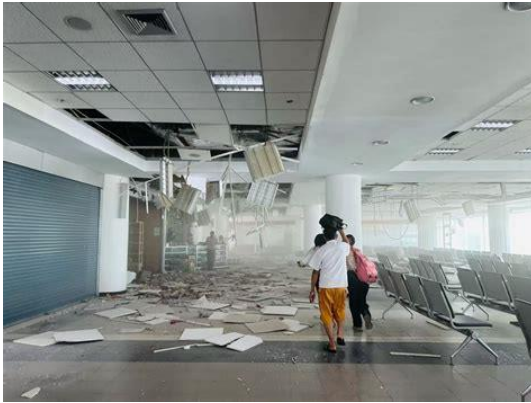
Mandalay International Airport

- Close to rupture zone
- Part of runway is in the observation zone
